# Island County 2023 Shoreline Armor Survey – Approach and Phase 1 Results

#### **TECHNICAL MEMORANDUM**

From: Lauren Ode-Giles and Andrea MacLennan, Herrera Environmental Consultants, Inc.

Subject: Island County 2023 Shoreline Armor Survey – Approach and Phase 1 Results

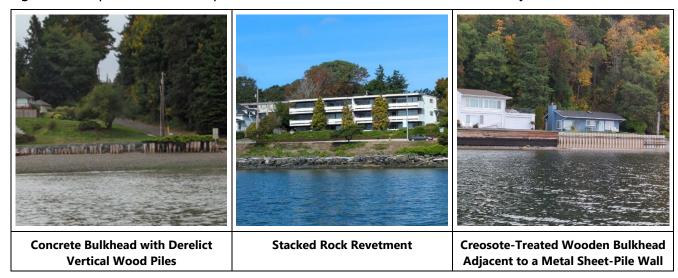
Figure 1. Representative Examples of Shoreline Armor Encountered on Whidbey and Camano Islands.

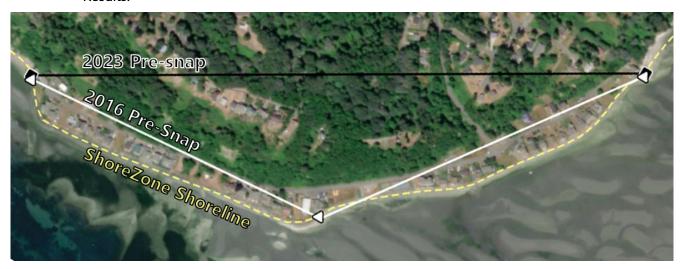
Figure 4. Example of Difference in GPS Point Placement in 2016 and 2023 Mapping Efforts Relative to the ShoreZone Shoreline that Produced Different Pre-Snap Shoreline Armor Measurement Results.

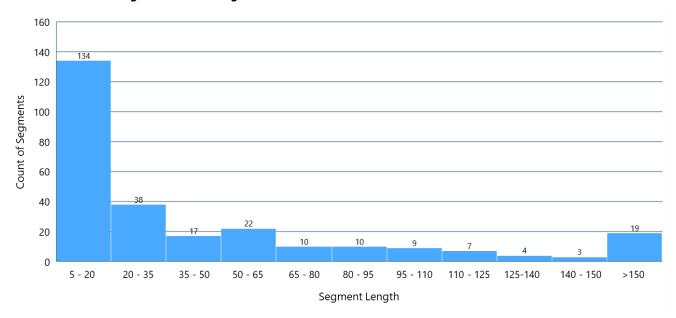
Of the 391 shoreline armor segments mapped only in 2023 but not in 2016 (representing a potential addition of armor), 118 were screened out for having a length less than 5 feet, leaving 273 segments of potential new armor. Of these, 134 (49 percent) had a length between 5 to 20 feet, 55 (20 percent) had a length between 20 and 50 feet, and 84 (30 percent) had a length greater than 50 feet (Figure 5). The spatial distribution of potential new armor segments by length is explored in Figure A.4.

Figure 5. Distribution of the Lengths of Potential New (present in 2023 but not in 2016) Shore Armor Segments.

Armor segments with a length of less than 5 feet were omitted.

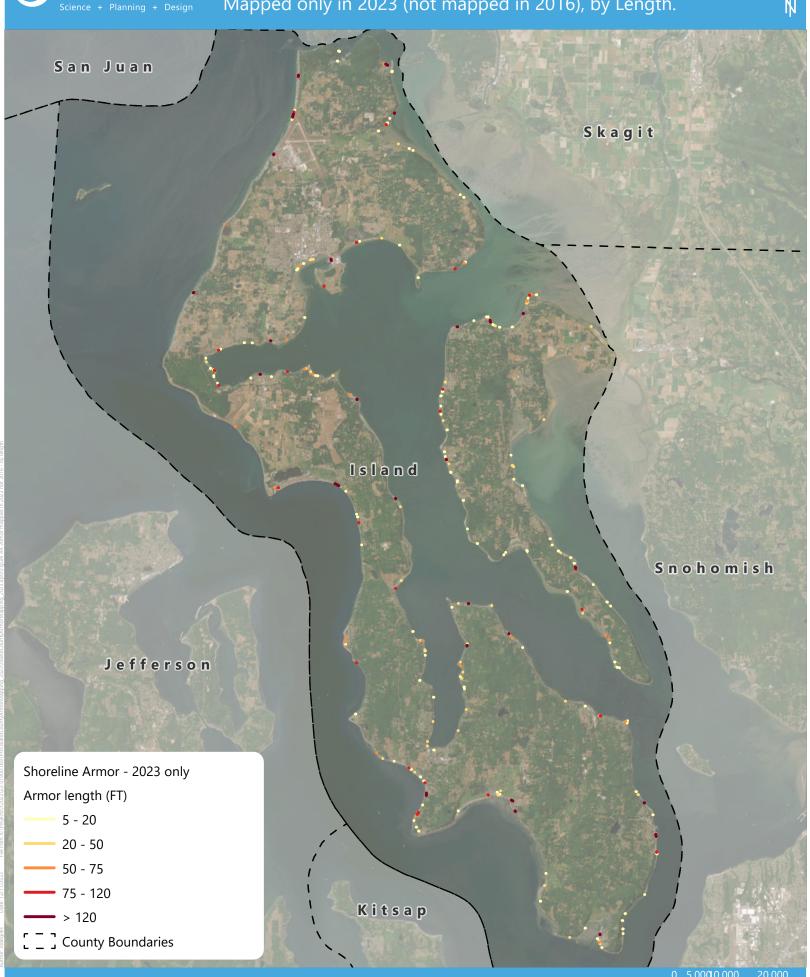
Figure A.4. Shoreline Armor in Island County, WA, Mapped only in 2023 (not mapped in 2016), by Length.

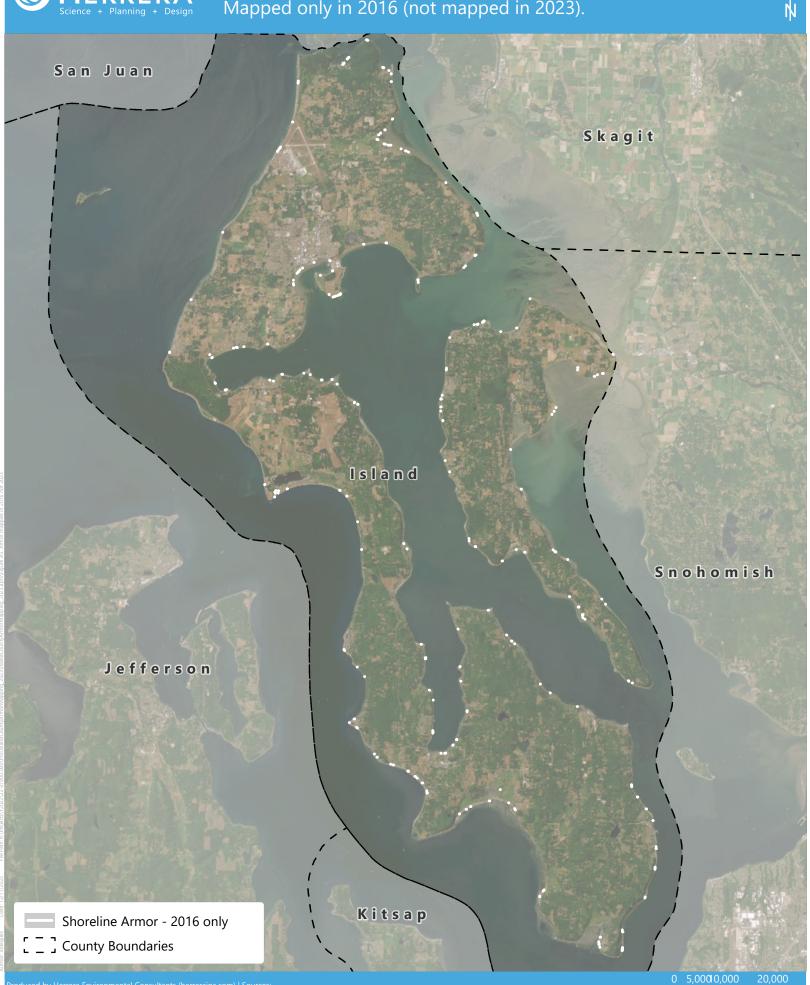
A total of 308 shoreline armor segments were mapped in 2016 but not in 2023, representing a potential loss of armor. Of those, 111 segments had a length of less than 5 feet and were screened out of the preliminary change analysis results. Of the remaining 197 armor segments mapped only in 2016, 80 (41 percent) had a post-snap length between 5 and 20 feet, and 117 (59 percent) had a length greater than 20 feet.

Figure A.5. Shoreline Armor in Island County, WA, Mapped only in 2016 (not mapped in 2023).
