COUNTY: Island Grant Number: OTGP-2024-IsCoPH-00047 PROJECT TITLE: Armoring Analysis TASK NUMBER: 2.4 PERIOD COVERED: Jan 2024 - Dec 2025 DATE SUBMITTED: 07/17/2024

TECHNICAL MEMORANDUM

Date:	July 16, 2024
То:	Kelly Zupich, Island County Public Health Natural Resource Specialist
Copy to:	Island County Marine Resources Committee
From:	Lauren Ode-Giles, Andrea MacLennan
Subject:	Island County 2023 Shoreline Armor Survey—Methods and Results (Phase 1 and Phase 2)

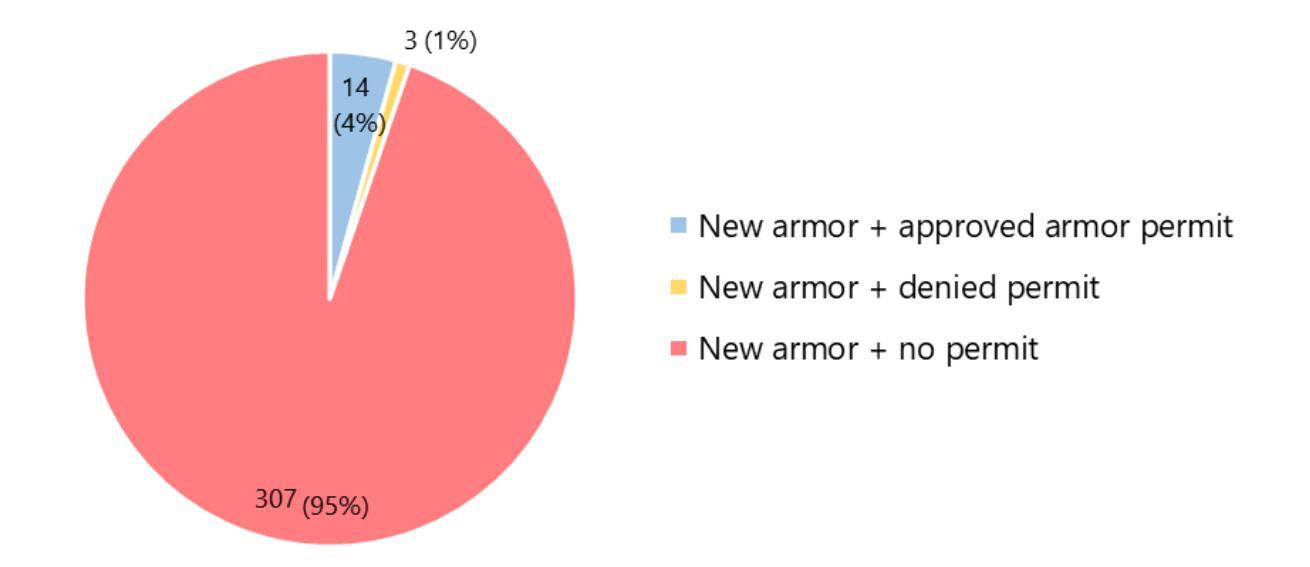
Figure 6. Parcels with New Shore Armor Associated with Approved, Denied, and No Permit Records.

Approximately 24,760 feet of shore armor was mapped as having been modified between the 2016 and 2023 events (Table 9). Where potential modifications to shore armor were mapped, 1,630 feet (7 percent) could be associated with an approved permit for armor repair, replacement, and/or modifications (Table 9).

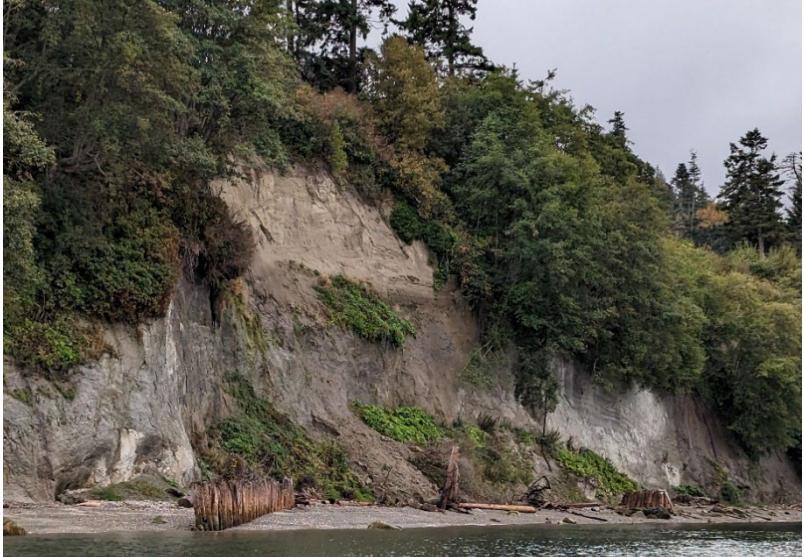
Figure 7. Partially-Armored Feeder Bluff on Whidbey Island.

This reach of shoreline was mapped as armored in 2016, but shore armor was largely buried or destroyed following a local landslide during 2023 mapping.

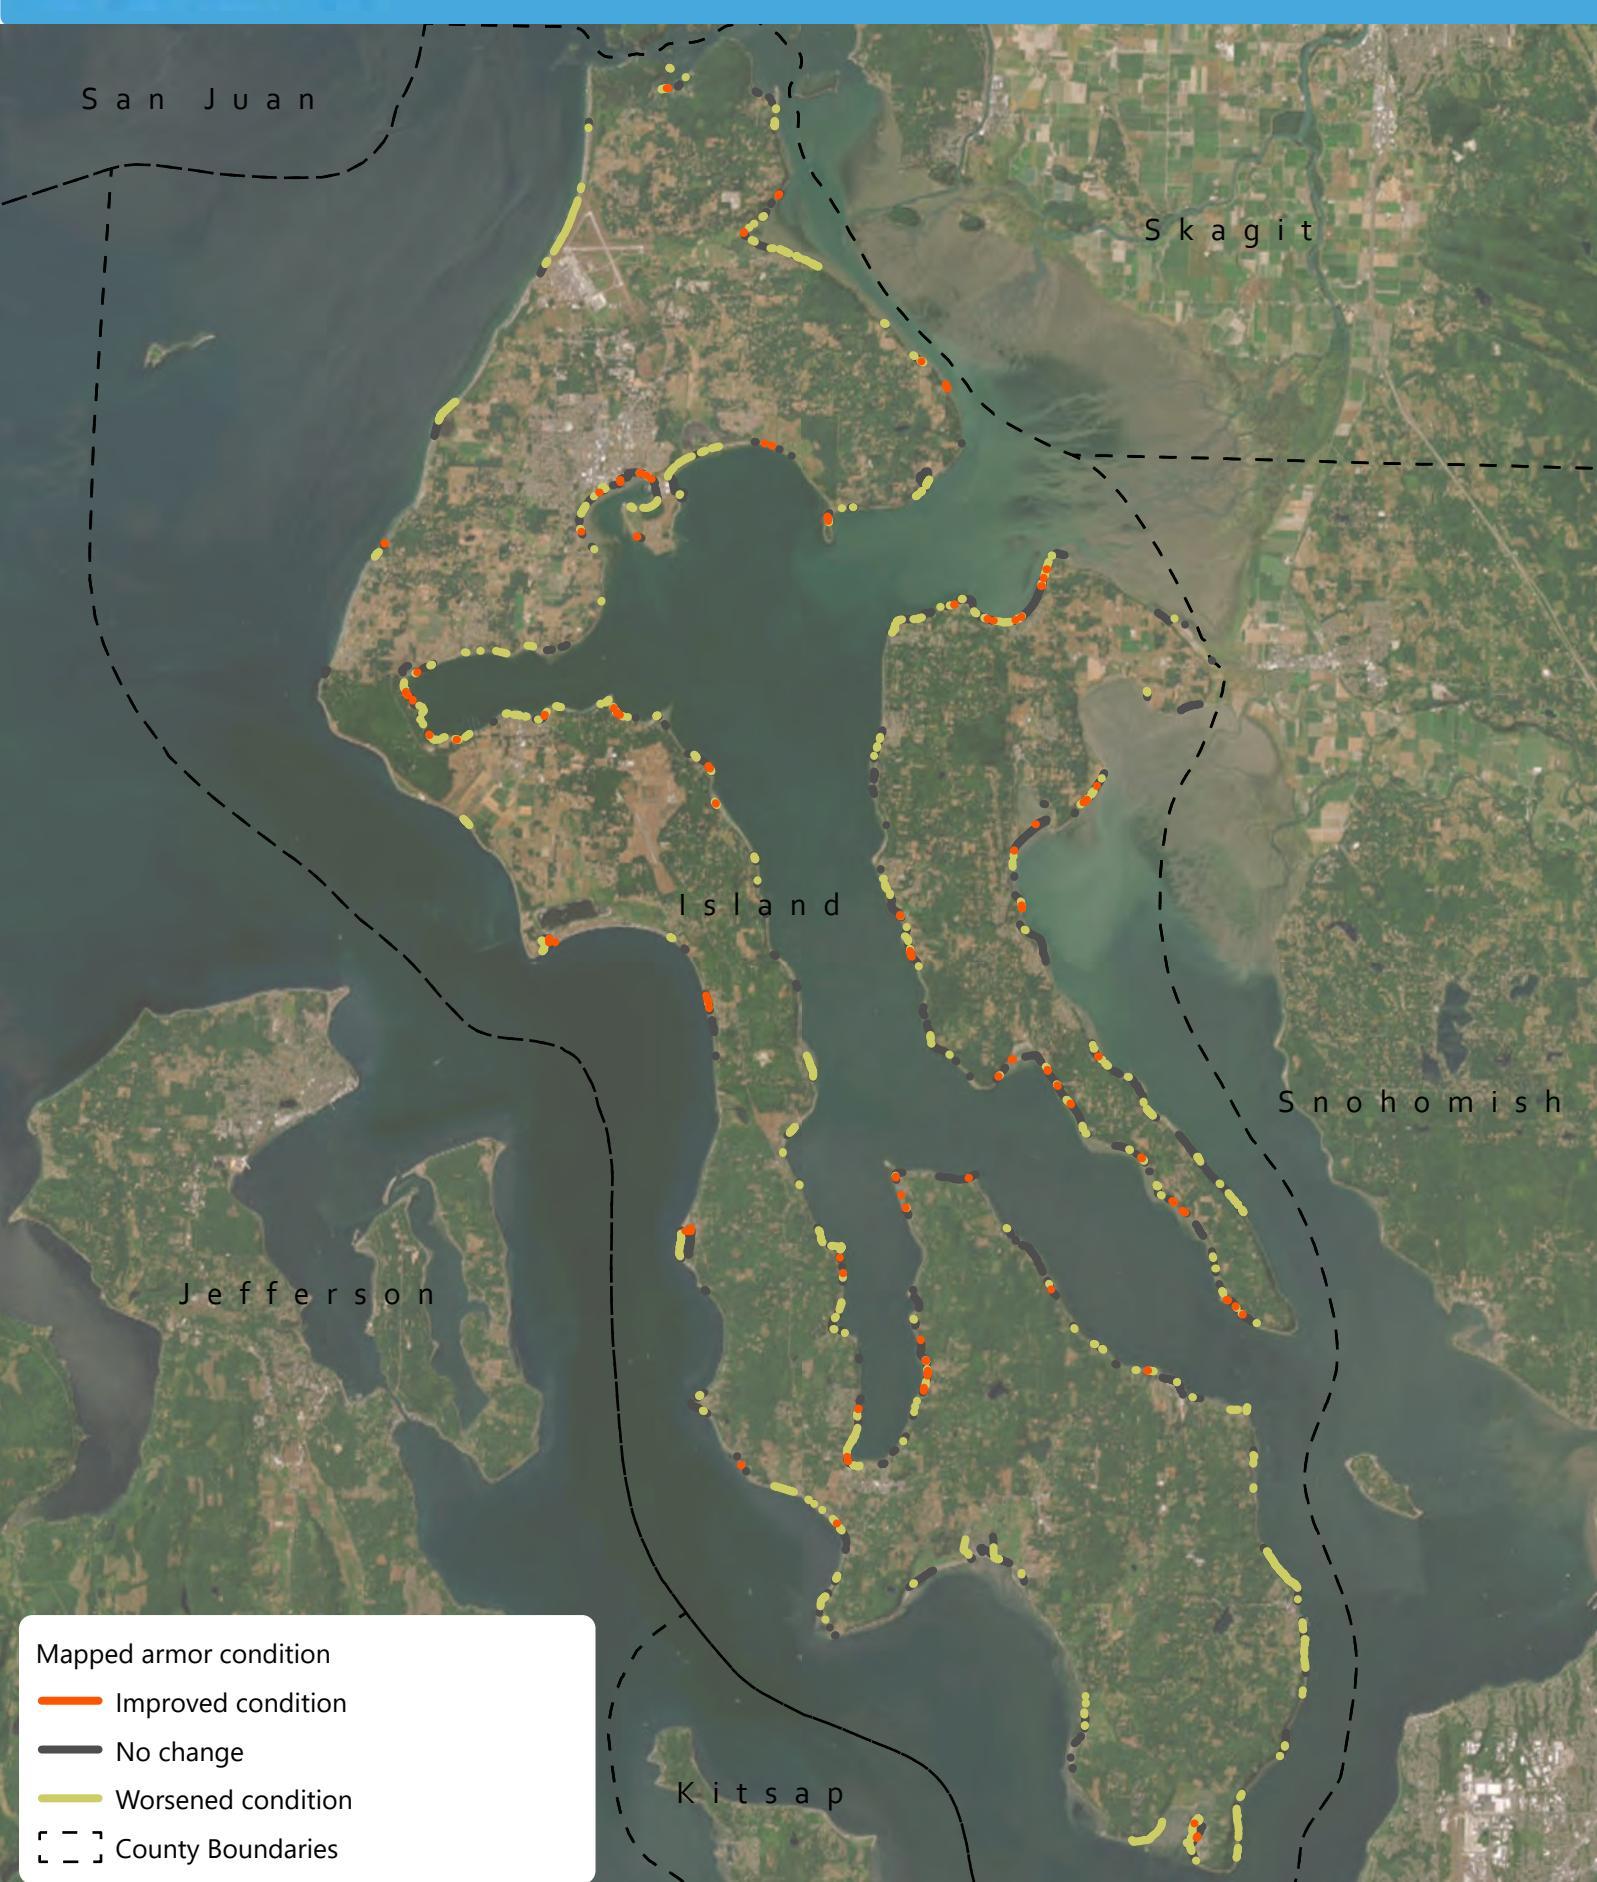
Figure A5.1 - Change in Mapped Armor Condition from 2016 to 2023, Island County

Of the approximately 271,300 feet of shore armor mapped in both 2016 and 2023, 261,300 feet (96 percent) either did not change in mapped condition (e.g., was mapped as "sound" in both 2016 and 2023) or worsened in condition (e.g., was mapped as "sound" in 2016 and "functional/failing" in 2023; Table 3). Mapped improvements in armor condition (from derelict to functional/failing, derelict to sound, or functional/failing to sound) were identified along 9,970 feet of shoreline (Table 3). The distribution of changes in mapped armor condition are included in Figure A5.

Overall, the condition of shore armor (armor present in both 2016 and 2023) appears to have worsened over the analysis period; 33,429 feet (12 percent) of extant shore armor was mapped as "functional/ failing" in 2016, compared to 95,488 feet (35 percent) of shore armor mapped as "functional/failing" in 2023 (Table 3). Several recent, noteworthy winter storms resulting from king tide events that coincide with storm surge are potentially driving this overall degradation in armor condition. Some of this change in mapped armor condition may also be the product of differences in shore armor interpretation between the 2016 and 2023 survey events.
