# Island County 2023 Shoreline Armor Survey – Approach and Phase 1 Results

#### **TECHNICAL MEMORANDUM**

From: Lauren Ode-Giles and Andrea MacLennan, Herrera Environmental Consultants, Inc.

Subject: Island County 2023 Shoreline Armor Survey – Approach and Phase 1 Results

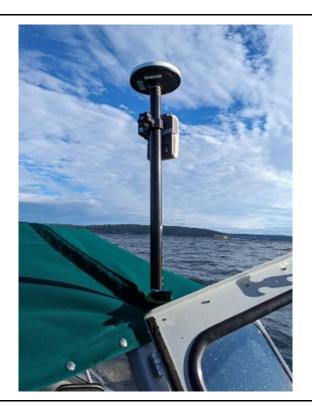
Figure 2.1. EOS Arrow 100 GPS Receiver and Antenna Mounted to the Field Boat.

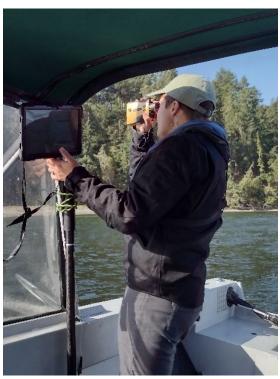
Figure 2.2. Field Staff Conducting Offset Mapping Using a TruPulse 360-Series Laser Rangefinder and Esri FieldMaps Application.

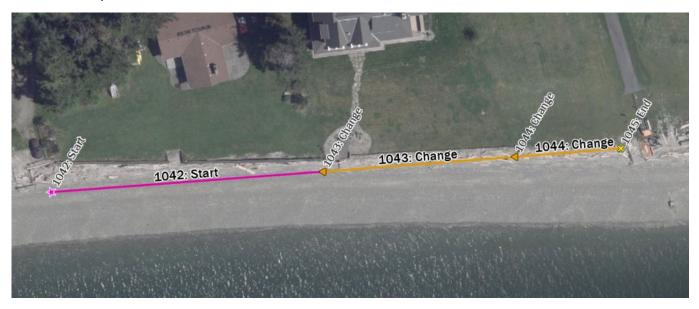
Figure 3. Example of Armor Lines Generated Using Sequentially Assigned Identifiers, with Attributes Populated from Start to End.

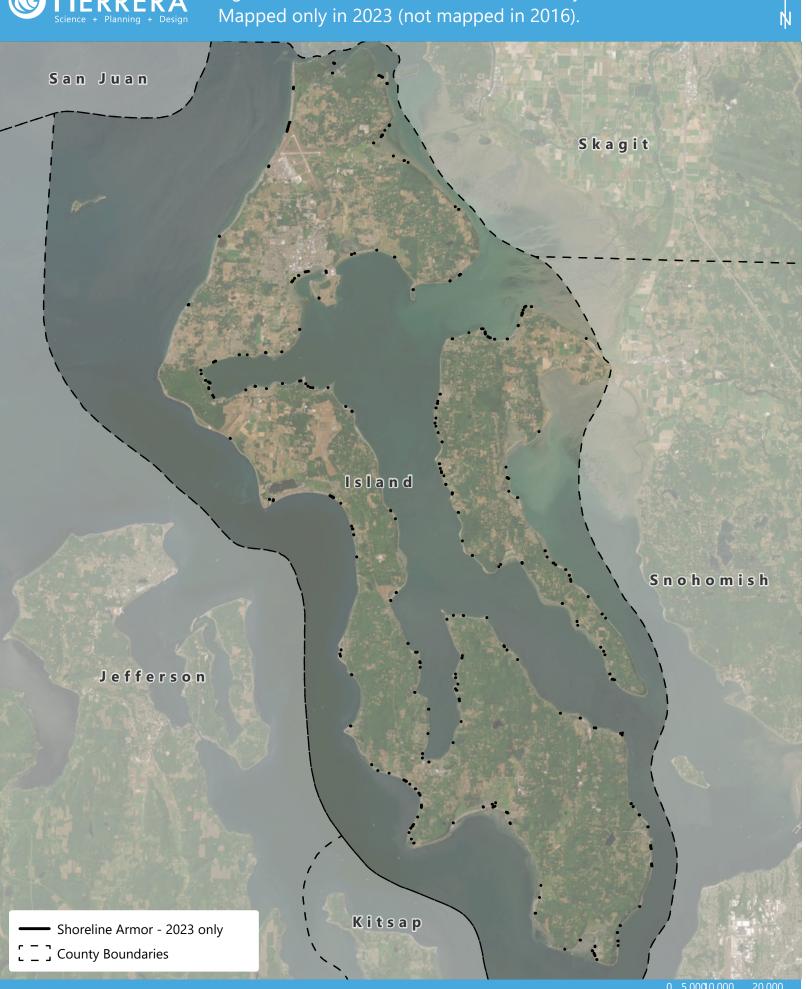
Figure A.4. Shoreline Armor in Island County, WA, Mapped only in 2023 (not mapped in 2016), by Length.
