PROJECT TITLE: Island County Marine Resources Committee Operations and Projects

DELIVERABLE: 2.6 – Eelgrass aggregated data and report on 2016 eelgrass monitoring

# 2016 Aerial and Underwater Videography Assessments of Eelgrass in Island County

Island County Marine Resources Committee

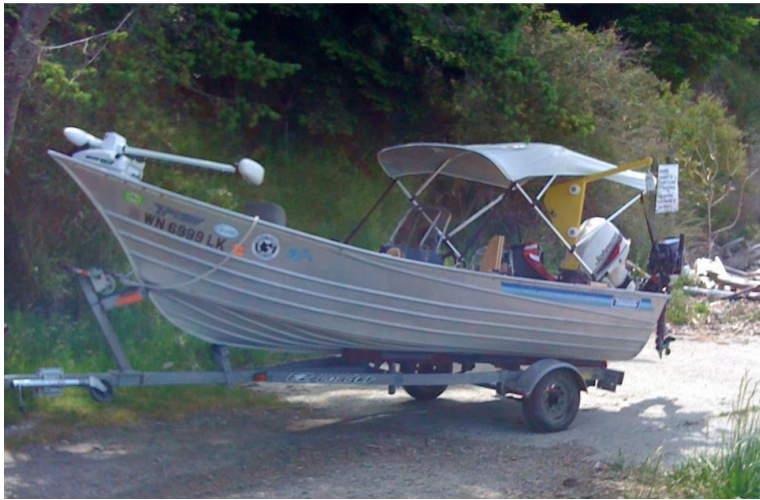
Figure 2. Boat used for ICMRC team's underwater video data collection.

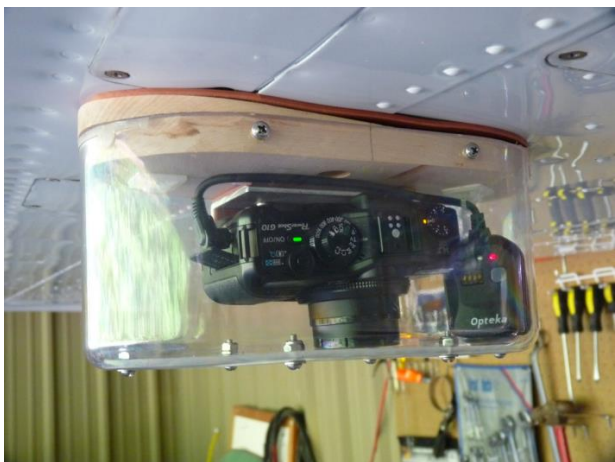
Figure 3. Wing mounted Camera

A detailed description of the tasks required to complete the aerial photography segment of this project have been defined previously in the attached document: "Aerial Photography Manual v1\_1.doc". Briefly, overlapping vertical photographs of the shorelines of interest were taken from a small airplane using a wing-mounted camera controlled remotely from the cabin. The images were geo-tagged with the GPS data from the navigation system of the plane to identify the position of each photograph and markers were placed on a map for each photograph. Since sites require more than one image to cover the entire area, overlapping photographs were stitched together into a collective site image. The images for each site were then geo-referenced using ArcGIS 10 to a base map (usually ESRI Satellite maps) to allow comparison with other GIS data (underwater videography data primarily) and to make accurate measurements of the size of features of interest.

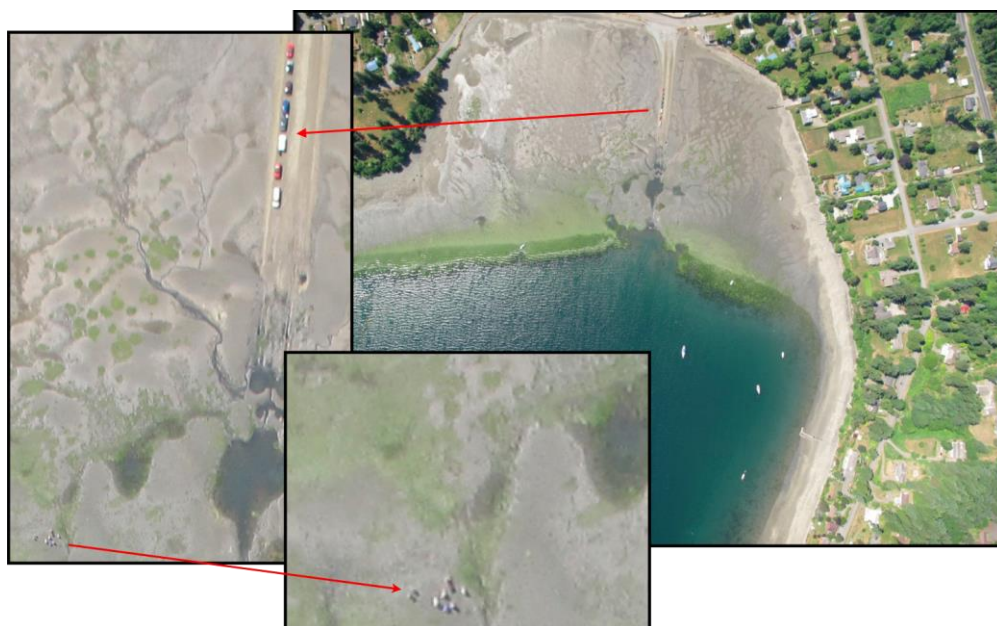
Figure 5. Resolution of single photo over Holmes Harbor

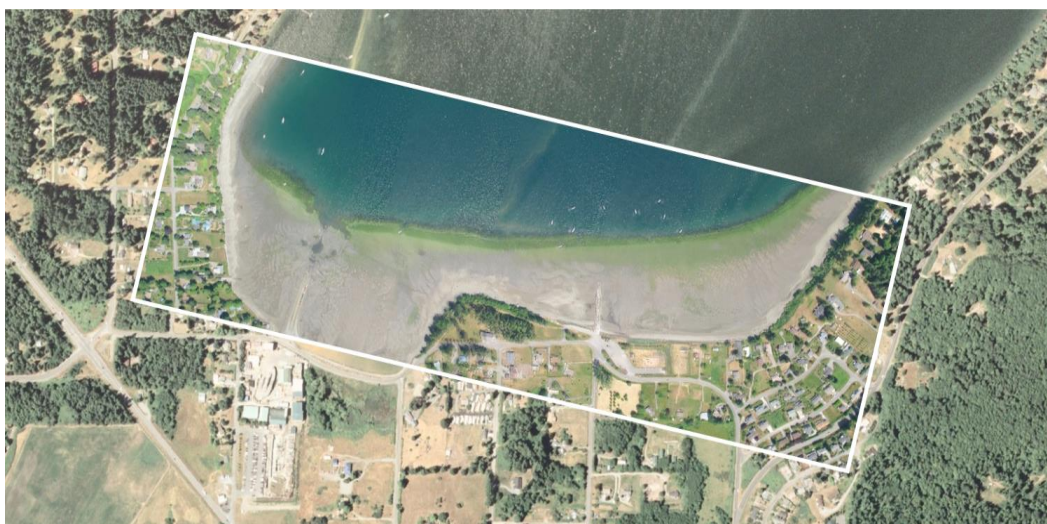
Figure 6. Geo-referenced low-tide site image of Holmes Harbor site sw0932.

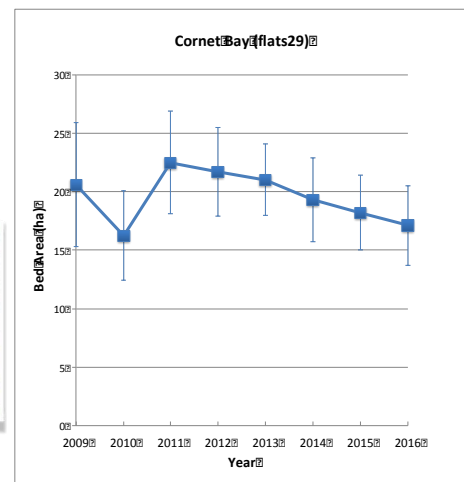
Figure 14. Aerial and Underwater Videography results for Cornet Bay (flats29) in 2016 and historic Bed Area values from 2009 (top images). Sonar map and bed area measurement based on area within sampling polygon (bottom image – red outline)

The results of our 2016 monitoring show the entire eelgrass bed area for 2016 ( $17.1 \pm 3.4$  ha) is not statistically different than all the average of 19.6 ha for all the previous years (see Figure 14). However the graph has shown a clear downward trend in eelgrass bed area since 2011 ( $R^2 = 0.98$ ; 17% loss), which is now difficult to explain simply by sampling variation. The error bars in Figure 14 are two standard errors based on the variance among the individual transects. These bars *really* represent the patchiness of the site rather than true errors of measurement.

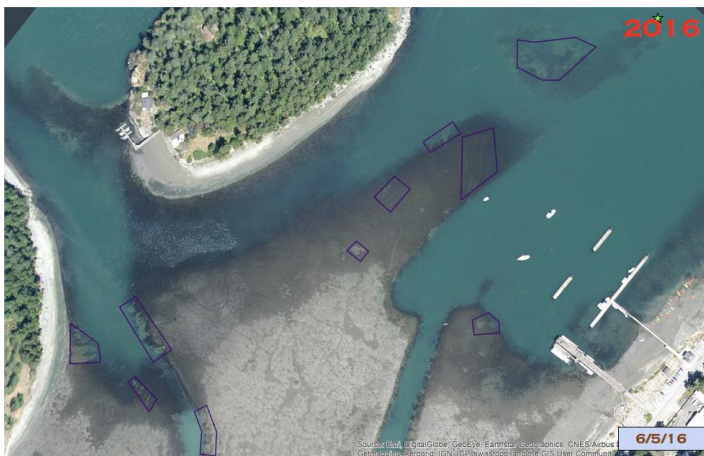
Figure 15. 2016 Aerial photo of likely anchor scour and propeller scars (examples in purple boxes).

Examples of the suspected presence of propeller scars and anchor scouring are seen in the higher resolution 2016 aerial image as in all previous years (see Figure 15). No quantitative analysis of boat damage from aerial images has been done because determining which bare patches are due to recent boating activity would be too speculative.

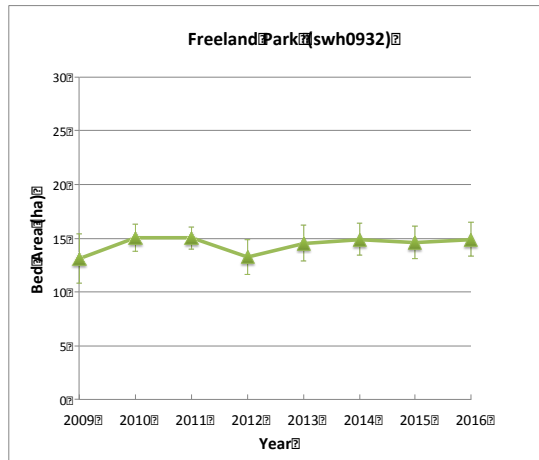
Figure 21. Aerial, Underwater Videography and Sonar results for Freeland Park (swh0932) in Holmes Harbor for 2015 and 2016 and historic Bed Area values from 2009.

No significant changes were seen from the underwater video analysis or aerial photo in the overall bed area or at the Nichols Bros. boatyard, where a difficult launch had taken place earlier in the year. The estimate of eelgrass bed area from the sonar data was somewhat higher than underwater video data estimates. This occurred even though some sonar data were missing in a shallow area (center of picture) where underwater video confirmed the presence of eelgrass. However there was close agreement between the sonar boundary (red line) and underwater video boundaries (green lines) for eelgrass presence.

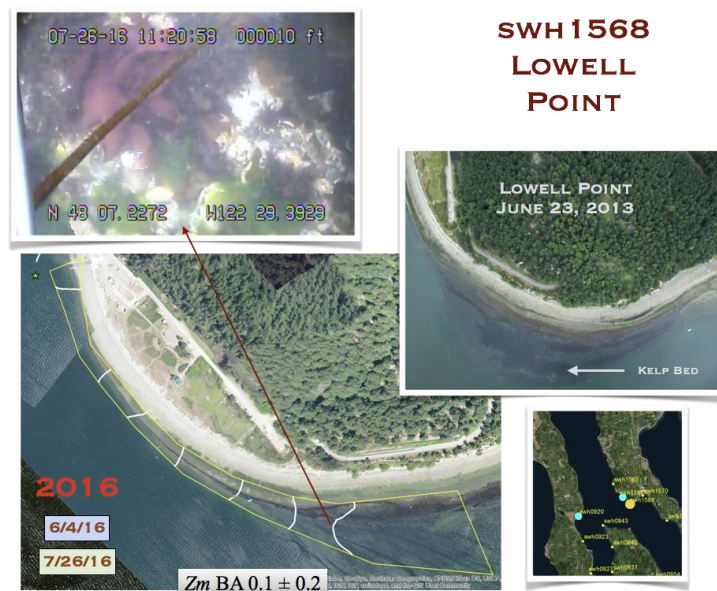
The underwater video reconnaissance effort at the south end of Lowell Point confirmed an extensive bed consisting of bull-kelp as well as many other species of macroalgae.

Figure 20. Aerial and Underwater Video showing kelp beds at the south end of Lowell Point

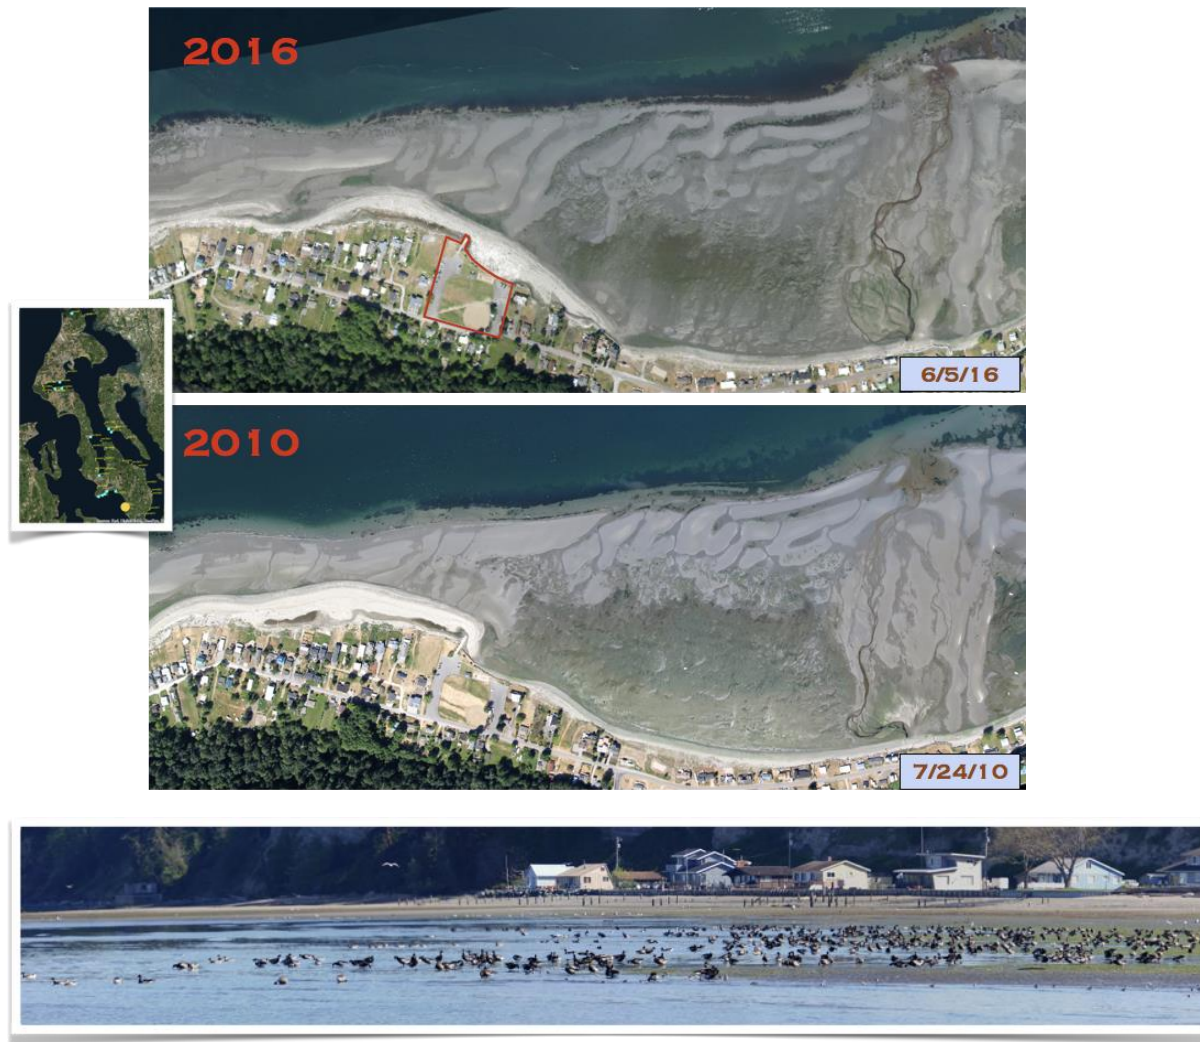
The beach at Dave Mackey Park (see red outline in Figure 23) and beach area northward (right in picture) have undergone significant natural reconstruction due to the littoral drift of sand from the south (left) during storm events over the last seven years. Yearly aerial images from 2010 show clearly the steady progression (data not shown, but available on request). The “new” beach (white sand) formation has changed storm drain runoff, eroded beach front boundaries to the north of the park, altered the flow of fresh water from the tide gate (outfall is above the aerial date box). It also appears to have reduced the size of the *Zjaponica* bed area (large vegetative growth area in the shallow flats). This *Zjaponica* eelgrass bed is an important food source for overwintering Brandt’s Geese each year (see panorama photo). Whether this beach remodeling has affected to the *Zmarina* bed area (dark area at the water’s edge) was uncertain. The *Zmarina* eelgrass areas were originally measured in 2011 by underwater videography ( $4.0 \pm 0.8$  ha) and re-measured in 2016 ( $5.7 \pm 0.7$  ha). The aerial photos also appear to show an increase in the eelgrass bed area. Of course, there may be no cause and effect between the littoral drift in the shallow areas and the *Zmarina* in the steeper dropoff region. It is also very likely that this seagrass is actually surfgrass (*Phyllospadix*) and not *Zmarina*. Surfgrass and eelgrass are equivalent for our purposes.

Figure 23. Aerial photos of the Maxwelton Beach area from 2010 and 2016. Note the change in shoreline due to littoral drift from the south (left) and decrease in *Zjaponica* bed area to the north (right) of Dave

Mackey County Park (red outline in 2016). Brandt's Geese in the winter of 2016 are shown feeding on *Zjaponica*.

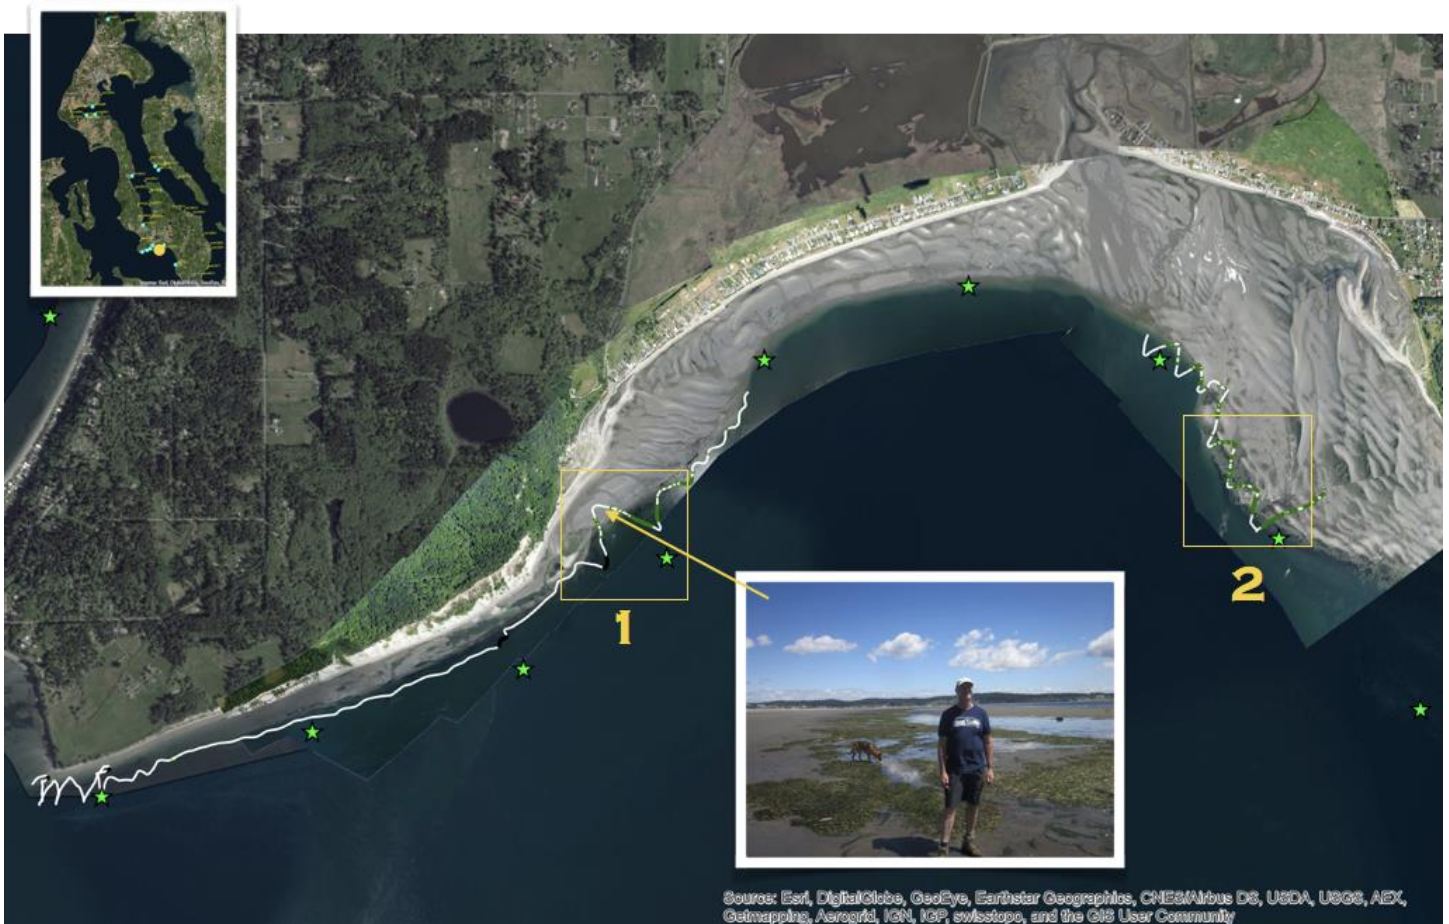
The north shore of Useless Bay (see Figure 25) is quite long and spans seven WADNR sites (cps0766-cps0772). The shore varies from a large flats (cps0766 – right side of photo) to a narrow fringe (cps0772 – left side of photo). Just as with Dave Mackey Park, the seagrass (probably surfgrass) appears to follow the steep dropoff at the low tide edge. Because we have not surveyed this area before, we decided to do a zig-zag reconnaissance run to inspect, but not measure, the eelgrass distribution along the shoreline. Albert Foster is pictured near large clumps of seagrass at a low, low tide (yellow box #1 in Figure 25).

Figure 25. Aerial view of the north shore of Usless Bay with reconnaissance track of underwater video. Double Bluff shoreline (left two sites) appears to be devoid of seagrass. Areas containing seagrass (yellow boxes) are discussed below. Albert Foster inspecting seagrass at low, low tide – obviously his dog is doing all the work.

For this survey, the trip started on the western edge (left in Figure 25) of the shoreline and proceeded east in a slow zig-zag manner that quickly became a more of a straight line at a approximate depth of 10'. This was done to complete the survey of Double Bluff in a timely manner and because no eelgrass was seen during the zig-zag beginning. While there was nearly complete coverage of the seafloor with macroalgae of various species, we saw no eelgrass until we reached the area shown in the yellow box 1 in Figure 25. At that point we returned to a zig-zag pattern with results shown in Figure 26. The underwater video snap-shot of the position labeled "B" in Figure 26 shows the typical vegetation observed at that position and west (Double Bluff). It shows no eelgrass, but significant coverage of the seafloor with other vegetation. The underwater video snapshot of the position labeled "A" labeled shows the seagrass as encountered by Albert in Figure 25. Interestingly, the sonar map in Figure 26 does not

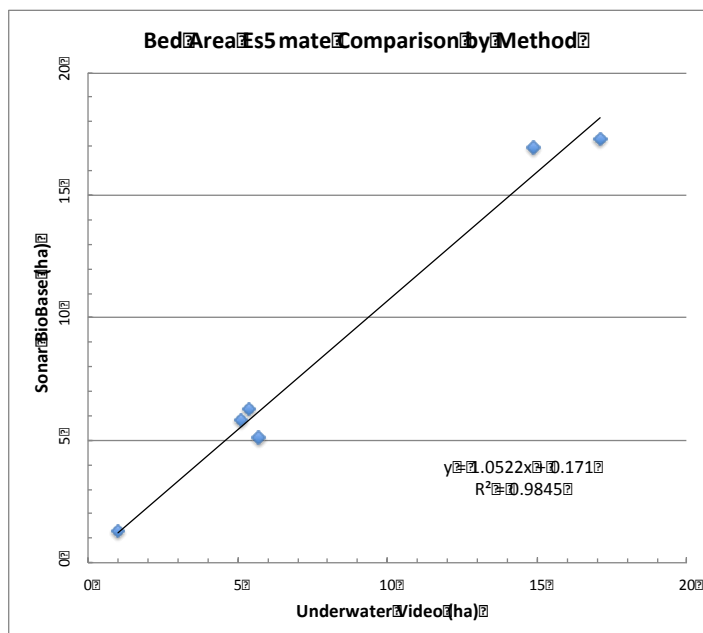
For 2016 we were able to complete underwater video analysis and sonar mapping to estimate eelgrass bed areas at six sites: flats29, sw0888, sw0900, sw0920, sw0932 and cps0761. The correlation of bed area estimates between these methods is shown in Figure 28. We had incomplete mapping at

Figure 28. Comparison of Eelgrass Bed Area estimates by underwater video analysis versus sonar mapping in 2016.

The correlation of the data points we have to date is good and we are encouraged to continue this investigation. We recognize the limitation of sonar to identify the type of vegetation based only on the sonar signal and realize that some form of visual validation is required. There appear to be some issues with vegetation on steep slopes or in very shallow water or under structures such as docks. At this point it appears we have both false positives and false negatives to better understand. However, we greatly applaud the advantages of : (1) being able to get complete coverage of a site in less time that it takes to do ten underwater video transects, (2) having commercial equipment that is readily available and less expensive, (3) having commercial data processing services, (4) requiring only a single operator and (5) being able to use the equipment on small platforms (e.g. kayaks). Albert agreed to continue testing this approach with us in 2017 (as of this writing he has completed data collection) and determine what it would take to fully implement the method as a replacement for our aging underwater videography equipment (and operators!). There will be a much more thorough report next year when we have more data and experience.
