# Island County Armor Mapping (Nearshore Data Collection and Synthesis) Final Technical Memorandum

Prepared for: Island County Department of Natural Resources

Prepared by: Coastal Geologic Services Inc.

Authors: Branden Rishel, Andrea MacLennan, Jim Johannessen, and Alison Lubeck  
September 30, 2016

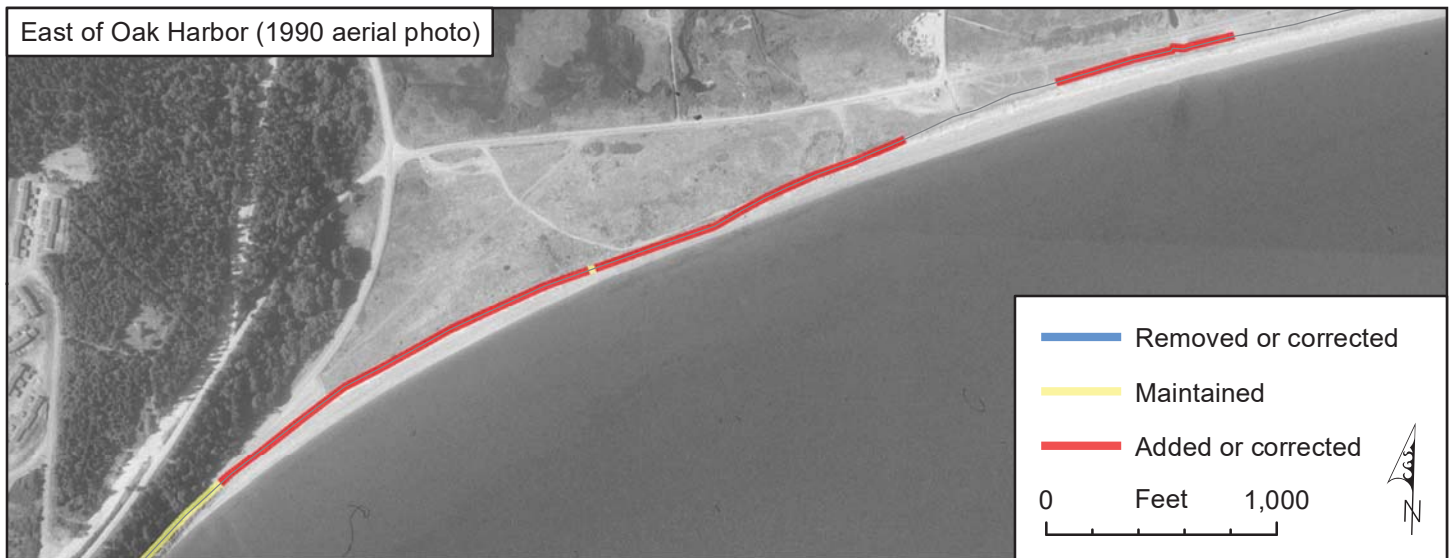
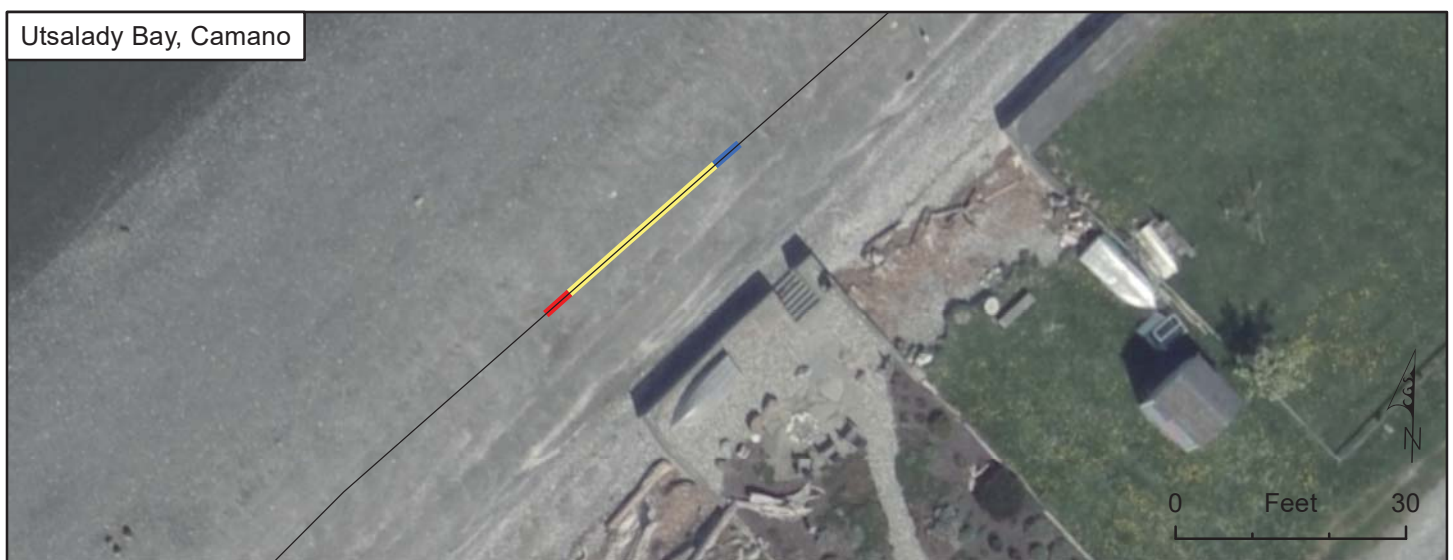
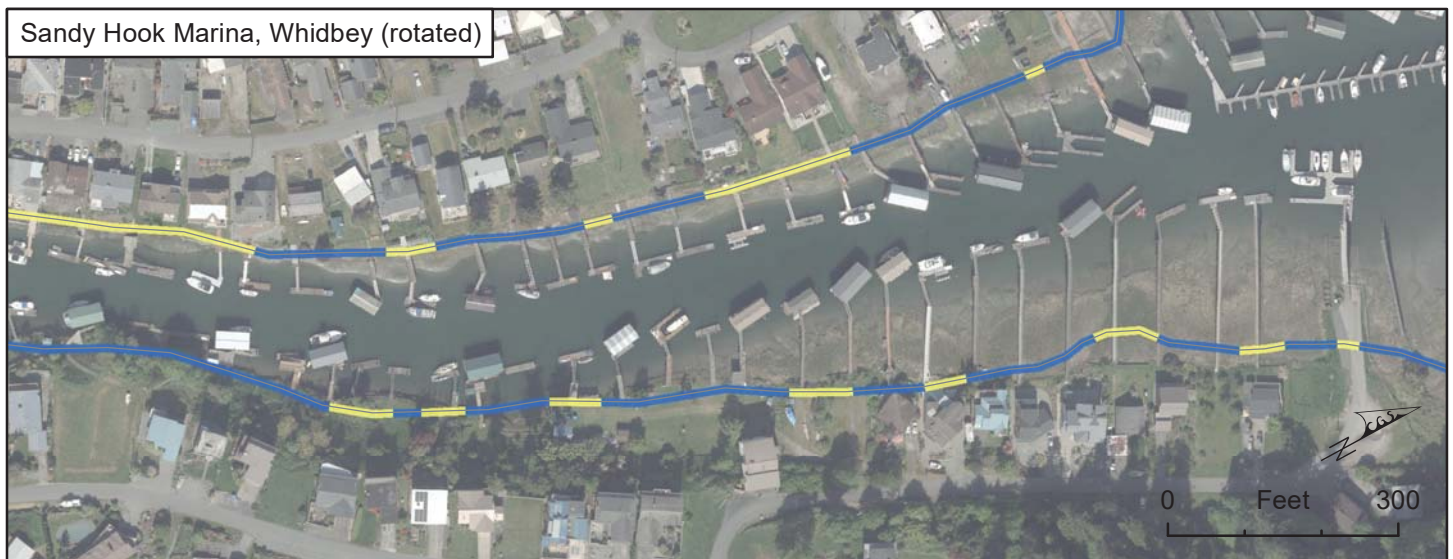
**Figure 4.** Armor comparison problems. Armor omitted from historical data (top), Armor sliding alongshore due to snapping or accuracy differences (middle). Armor mapped as removed, likely a historical commission error (bottom).  
*Island County Armor Mapping*

Figure 4 shows the following three examples of problems with the data comparison:

and ShoreZone shoreline snapping, some maintained armor may be transposed slightly along the shoreline. Figure 4 shows an example of this. For this reason, data users may decide to exclude from future analysis armor segments shorter than 20 FT, the minimum mapping unit. This totals about 3,125 FT of armor, or 0.28% of the total shore length.

**Figure 4.** Armor comparison problems.
